## Maintaining the Historic Legacy

The US Naval Academy, the undergraduate college for the country's naval service in Annapolis, MD, was originally founded in 1845 by then-Secretary of the Navy George Bancroft. Located on 10 acres of old Fort Severn, the academy campus is sited where the Severn River flows into the Chesapeake Bay. Across the Severn River is the Naval Support Activity Annapolis, the site of a recent remediation project.

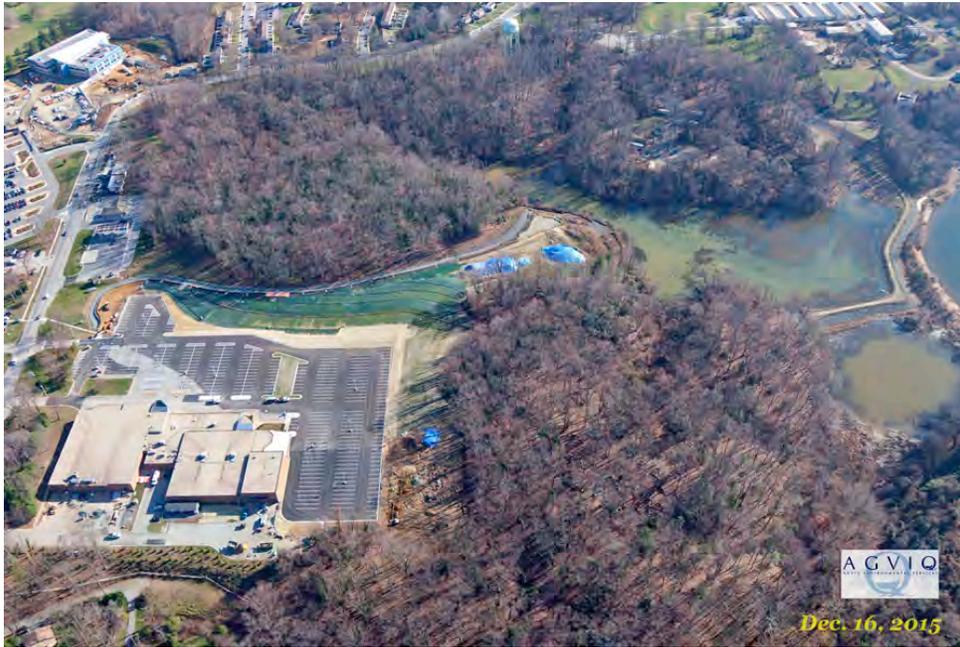
Aerial view of the spillway, Photo courtesy of AGVIQ, LLC and US Naval Academy

Under the Navy's Environmental Restoration Program, the lagoon berm was rebuilt and principal and emergency spillways constructed to contain sediment and prevent erosion from the facility's stormwater runoff.

Today the berm has been successfully rehabilitated with erosion mats, riprap, tons of gravel, topsoil, grass, and realignment of a road. These improvements have made a big difference controlling erosion and ensuring the berm is protected from major storms. The BMP products play a key role, located at the critical point of the principal spillway where lagoon waters are making their final way towards the Severn River. The trash screen keeps large branches and debris from clogging the system, and the Snout funnels clean water through the spillway toward the river.

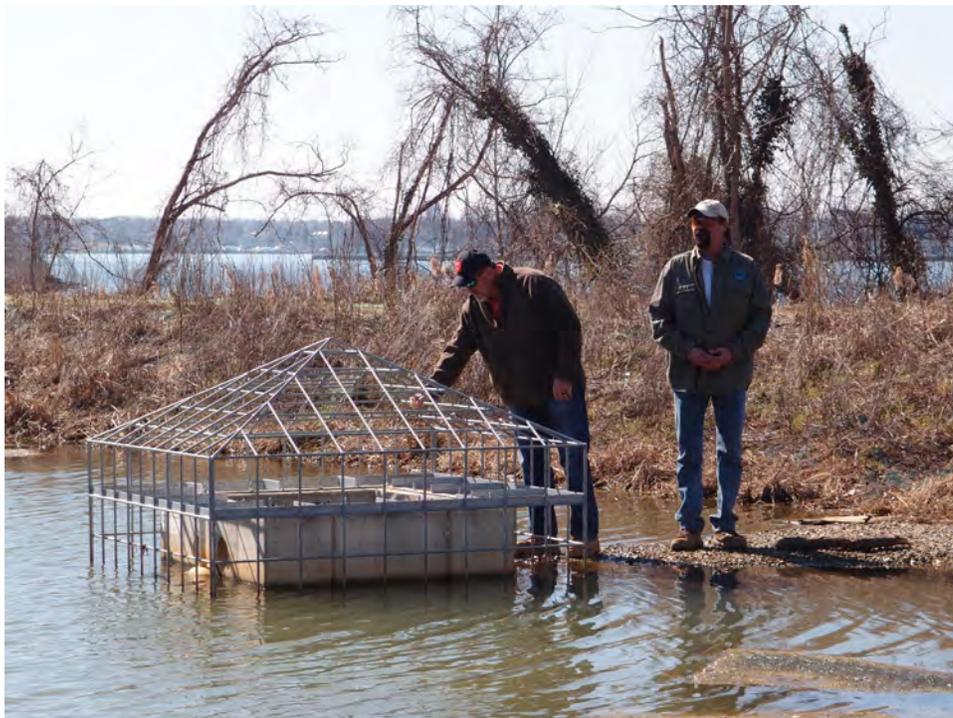
Mark Friar and a colleague inspect the water quality structure with the SNOUT and TrashScreen

The Snout and the Best Management Products trash screen were installed during the project.

“We got hooked up with T. J. Mullen and his company, BMP, through our project engineers, CH2M Hill, and the site quality-control manager,” says Friar. “As we were procuring the principal spillway concrete structure, now in the lagoon, they suggested we include the Snout and trash screen from BMP to achieve design requirements in providing protection of the principal spillway inlet from debris. The Snout and trash screen specifications were provided to NAVFAC for review and subsequently approved for use on the principal spillway structure.”
